**CLEAN WATER ACT  
COMPLIANCE INSPECTION**

Facility Name

Moorefield, WV 26836

On-Site Inspection – May 22, 2012

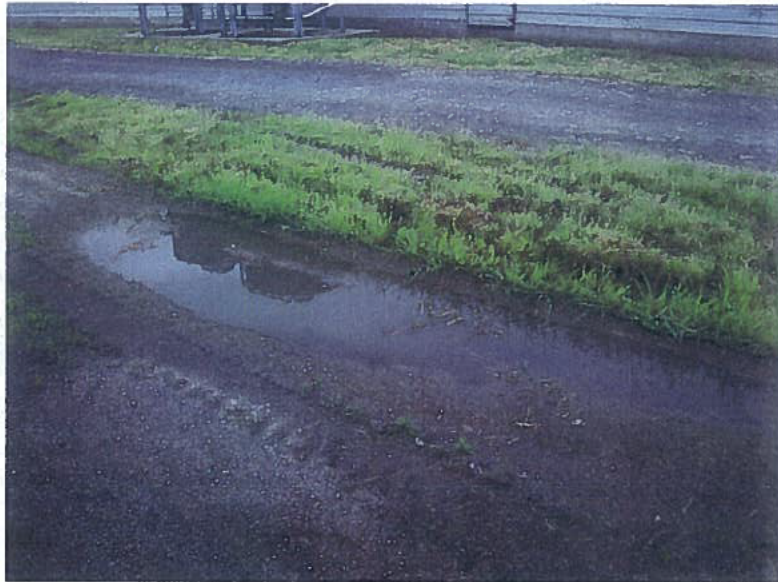
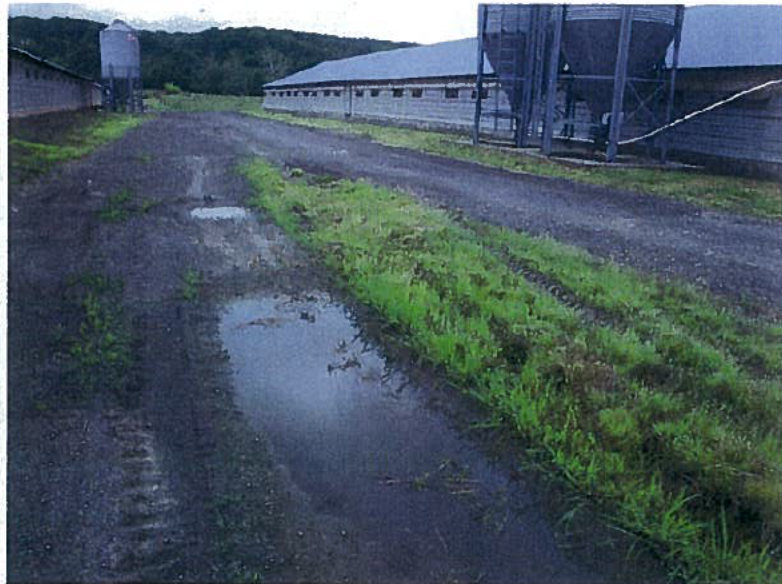
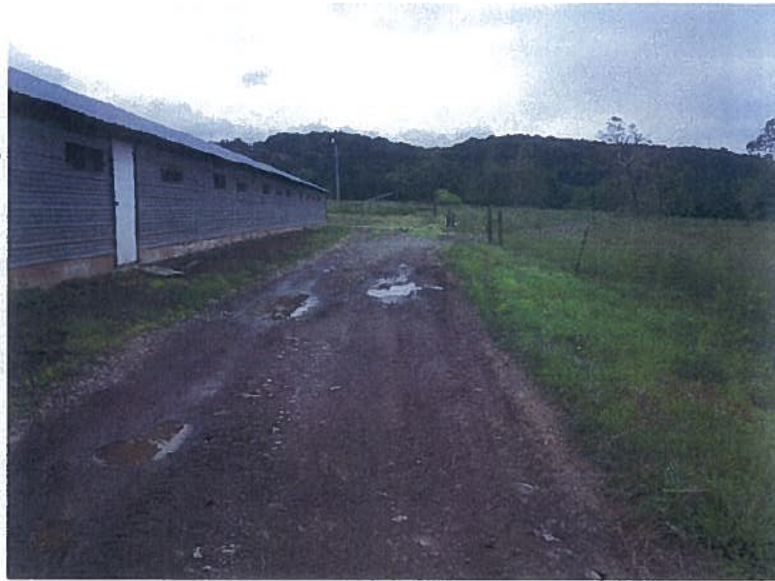
[REDACTED] escorted everyone in attendance through the Facility pointing out the various areas where management changes were proposed. During the tour, Ms. Zieba took photographs (see Appendix B). As we walked on the access lance between Houses 3 and 4, I observed stormwater standing in puddles (see Photos 3, 4, 5, and 12).

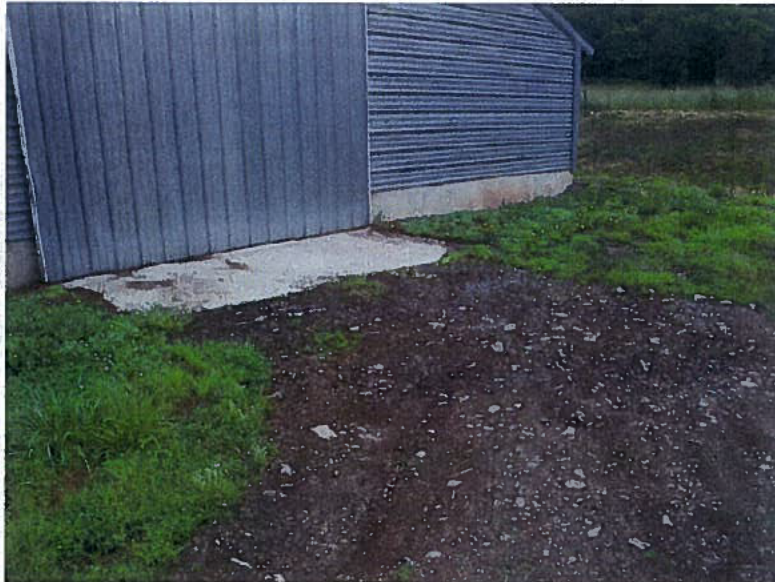
Photo 6

There is a ditch along the east and south sides of House 4 (see Photos 7 and 9). The end pad at the south end of House 4 (see Photo 6) is approximately 30 feet from this ditch (see Photo 10). [REDACTED] stated that he has seen water flow from this ditch through a culvert under an access lane (see Photo 11) into the Farm Pond. One stream enters the Facility from the east (see Photo 8) and is conveyed through a culvert under House 4 to the Farm Pond (see Photo 13).

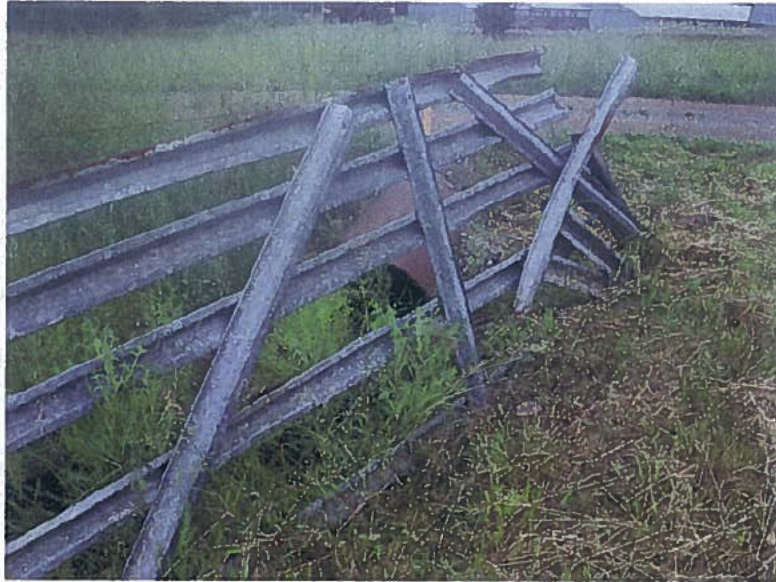
Photo 11	2012-05-22--10.49.49 [REDACTED]	Culvert to farm pond from ditch along east and south sides of House 4
Photo 12	2012-05-22--10.52.58 [REDACTED]	Access lane between Houses 3 and 4 with standing water in depressions; Farm Pond on the left
Photo 13	2012-05-22--10.54.32 [REDACTED]	Farm Pond
Photo 14	2012-05-22--10.54.49 [REDACTED]	Drainage path from access road area on the west side of House 4
Photo 15	2012-05-22--10.55.17 [REDACTED]	South end of House 3
Photo 16	2012-05-22--10.55.43 [REDACTED]	Area with ditch between Houses 2 and 3
Photo 17	2012-05-22--10.55.43-1 [REDACTED]	Area with ditch between Houses 2 and 3

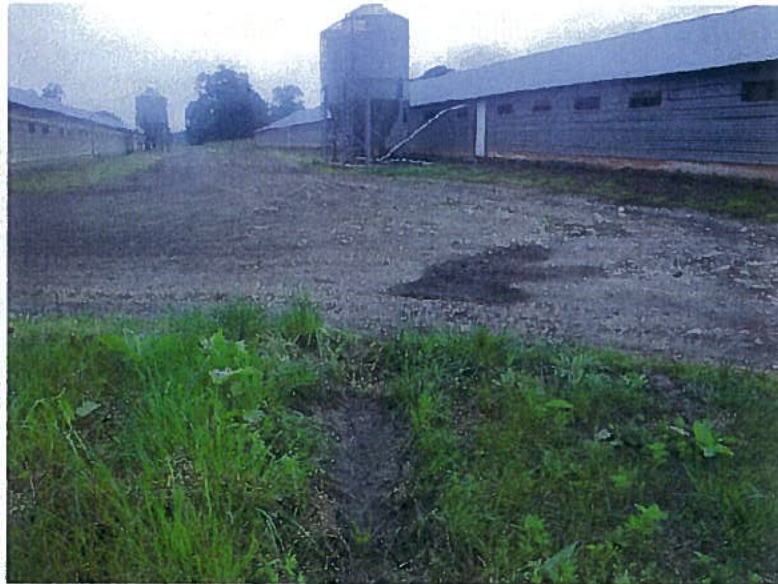
Photo 14

There are other ditches and drainage pathways that flow to the Farm Pond. I observed a drainage path from the access road area on the west side of House 4 (see Photo 14). There is a large ditch between Houses 2 and 3 (see Photo 16). This ditch flows through a culvert into the Farm Pond (see Photos 30-32). House 2 is at a lower elevation than House 3 (see Photos 17 and 24). I observed dust and feathers on the ground below the ventilations fans on Houses 2 and 3 next to the large ditch (see Photos 18, 25, 26, and 29). I observed drainage paths from the area adjacent to the ventilation fans on House 3 down toward the ditch (see Photo 19). There was standing water in the ditch between House 2 and 3 (see Photo 27). The water in the ditch was below a ventilation fan on House 2 (see Photo 28).

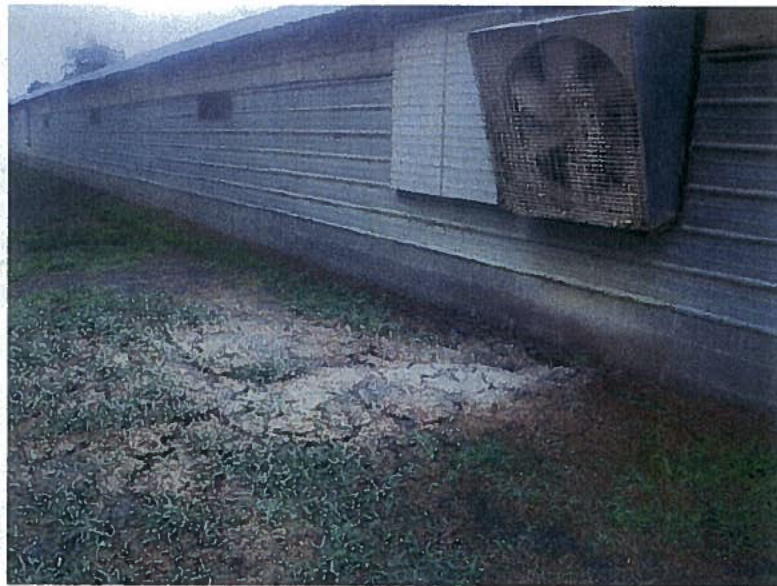
3. Stormwater, which flows through ditches between the poultry houses, can come into contact with dust and feathers deposited on the ground below the ventilation fans on the poultry houses.

Photo 18	2012-05-22--10.56.17 [REDACTED]	Ground below ventilation fan on the west side of House 3 with dust and feathers
Photo 19	2012-05-22--10.58.13 [REDACTED]	Drainage ditch from elevated area next to House 3 toward ditch between Houses 2 and 3
Photo 20	2012-05-22--10.58.57 [REDACTED]	Dust and feathers below other ventilation fans on House 3 in relation to drainage ditches
Photo 21	2012-05-22--10.59.52 [REDACTED]	North end of House 3
Photo 22	2012-05-22--11.00.04 [REDACTED]	Drainage path from north end of House 3 down access lane on the north side of the Facility
Photo 23	2012-05-22--11.00.31 [REDACTED]	North end of House 2
Photo 24	2012-05-22--11.00.41 [REDACTED]	Looking south from the north end of House 2 at ditch between House 2 and 3
Photo 25	2012-05-22--11.01.01 [REDACTED]	Dust and feathers below ventilation fan on House 2 in ditch between House 2 and 3
Photo 26	2012-05-22--11.01.55 [REDACTED]	Area below ventilation fan adjacent to saturated area in ditch between House 2 and 3

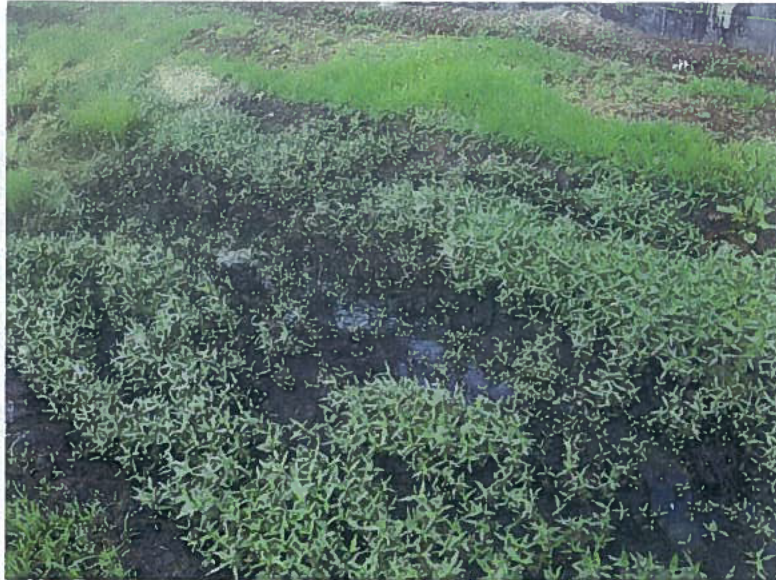
Photo 27	2012-05-22--11.02.58 [REDACTED]	Standing water in ditch between House 2 and 3
Photo 28	2012-05-22--11.03.04 [REDACTED]	Ventilation fan on House 2 in relation to standing water in ditch between House 2 and 3
Photo 29	2012-05-22--11.04.00 [REDACTED]	Area below another ventilation fan on House 2 adjacent to ditch between House 2 and 3
Photo 30	2012-05-22--11.04.45 [REDACTED]	Ditch between Houses 2 and 3 near culvert to Farm Pond
Photo 31	2012-05-22--11.04.58 [REDACTED]	Culvert from ditch to Farm Pond
Photo 32	2012-05-22--11.05.46 [REDACTED]	Culvert outlet to Farm Pond
Photo 33	2012-05-22--11.06.09 [REDACTED]	Mortality compost shed to the south of House 2 and west of ditch between Houses 2 and 3
Photo 34	2012-05-22--11.06.21 [REDACTED]	Manure shed with farm equipment
Photo 35	2012-05-22--11.06.54 [REDACTED]	Area between House 2 and manure shed
Photo 36	2012-05-22--11.07.07 [REDACTED]	Area in front of manure shed

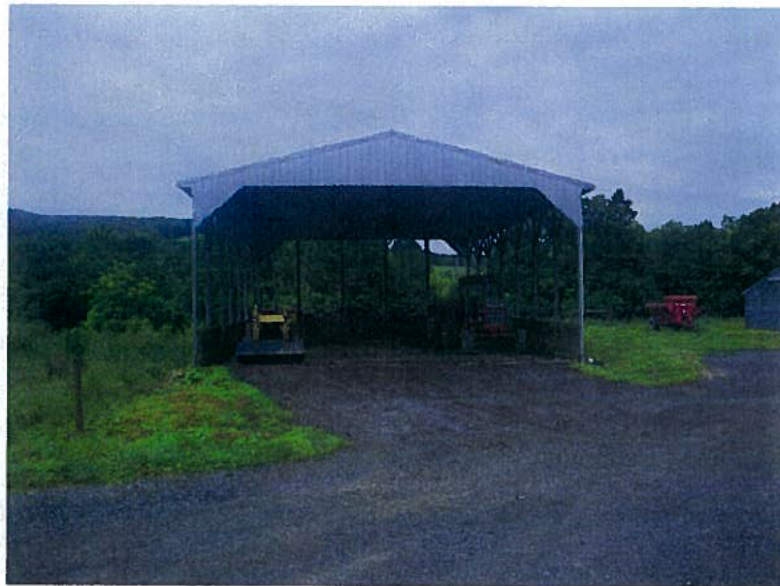
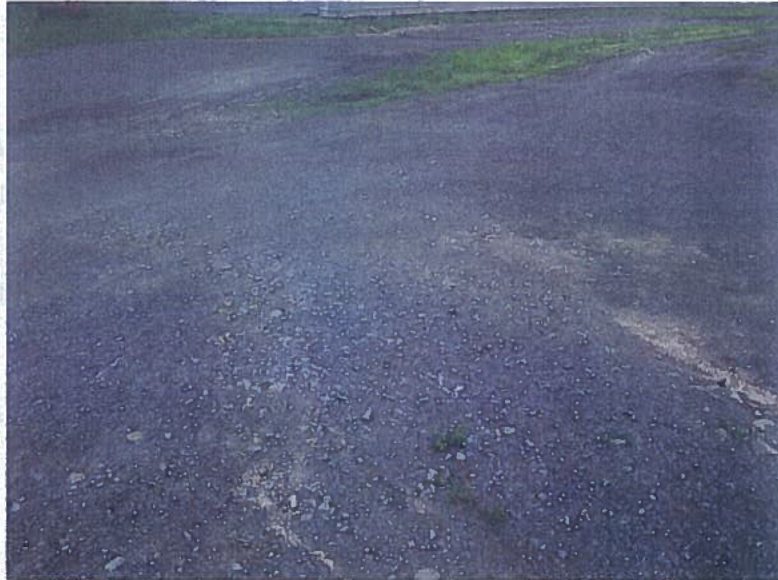
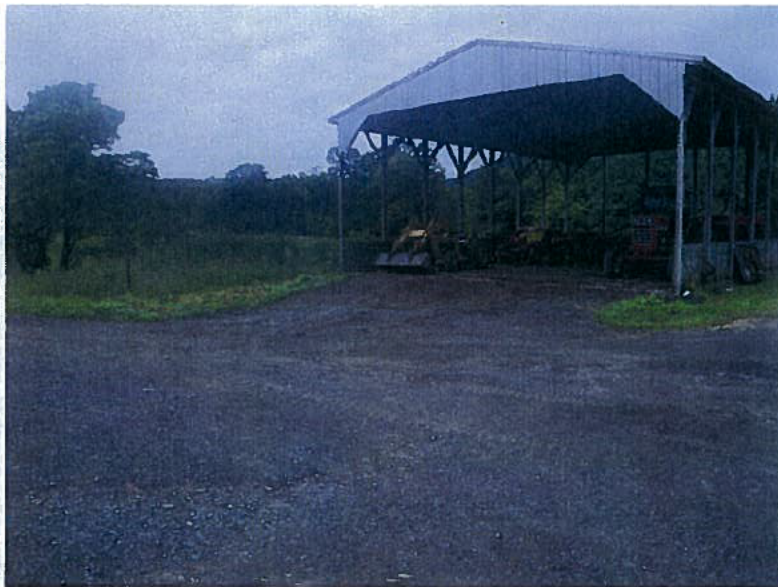
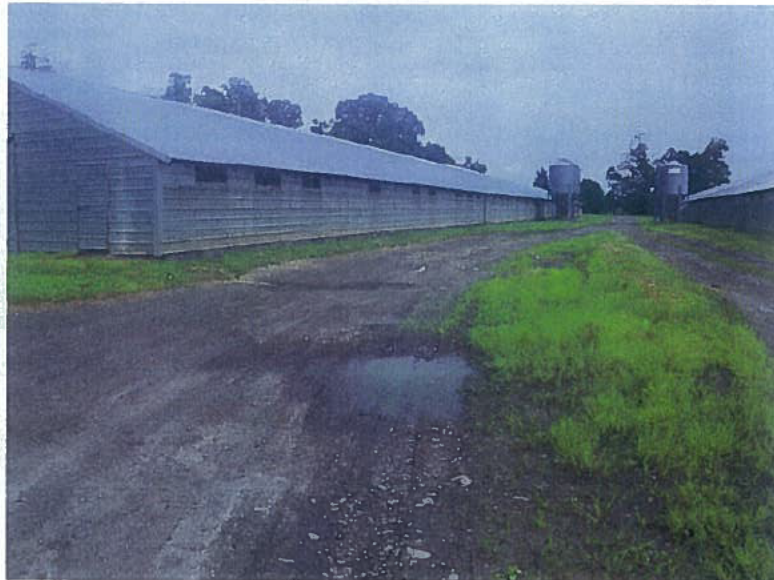
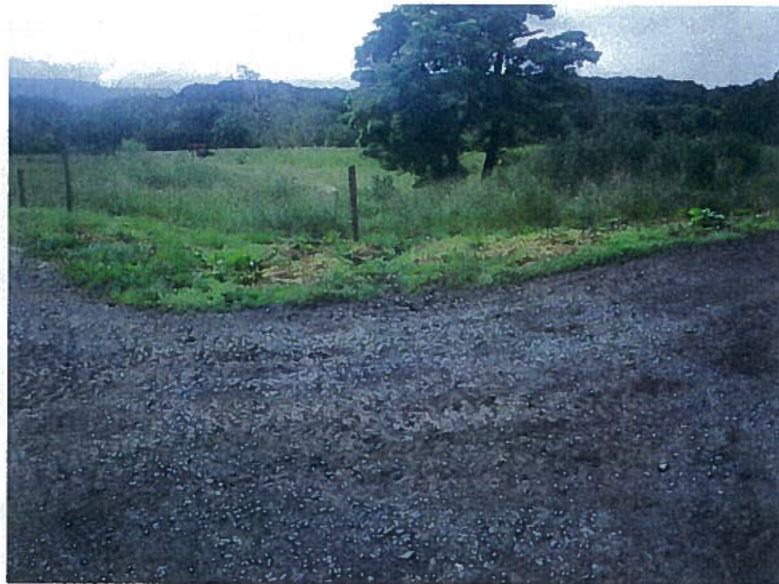
I observed a drainage path from the access road between House 1 and 2, across the area in front of the manure shed toward the vegetated area to the west of the Farm Pond (see Photos 34-38). I observed the drainage path continue downslope through the vegetated area toward the stream the Farm Pond discharges into (see Photo 39).
